Appendix D:

Windows

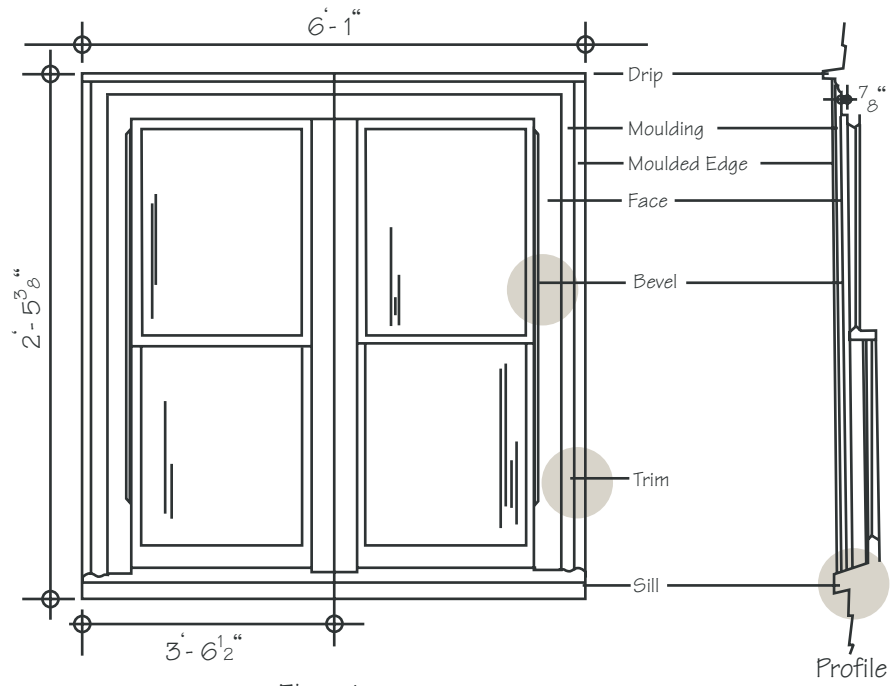
Elevation
Ground Floor Window

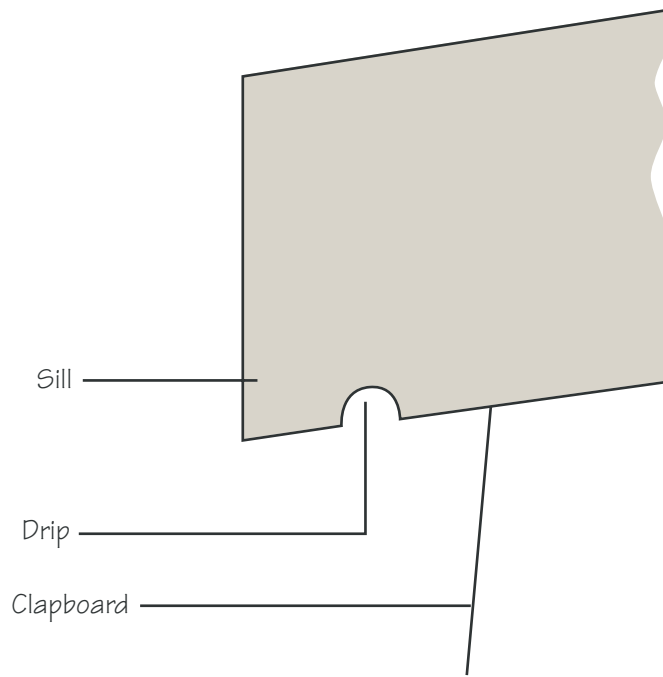
Sill Detail-2nd Floor

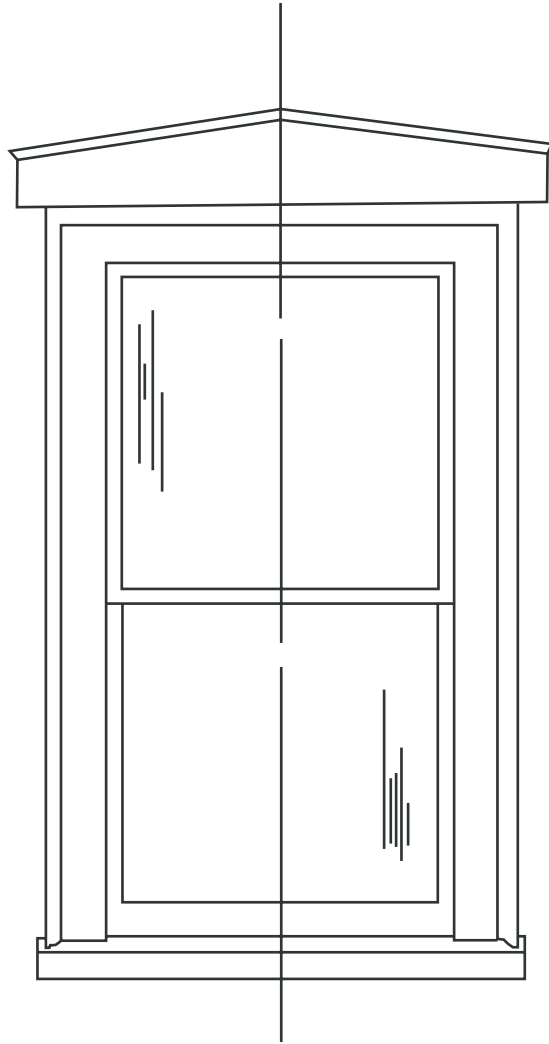
Elevation

Profile

Ground Floor Window

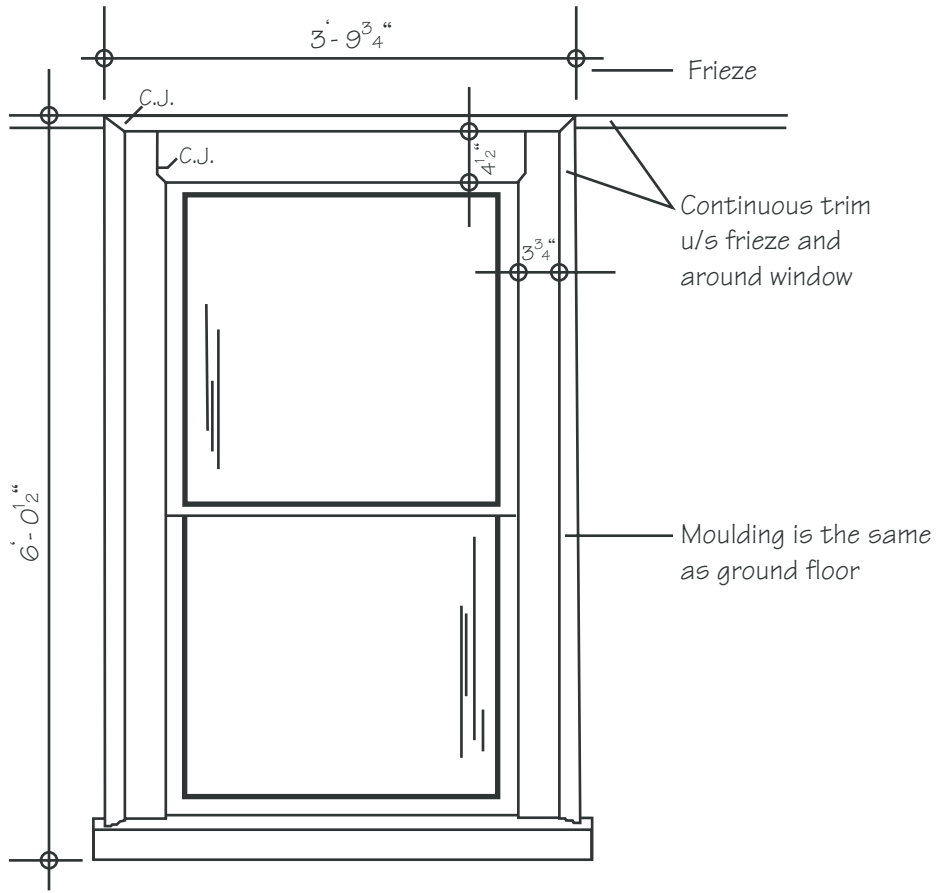
Elevation
 Second Floor Window

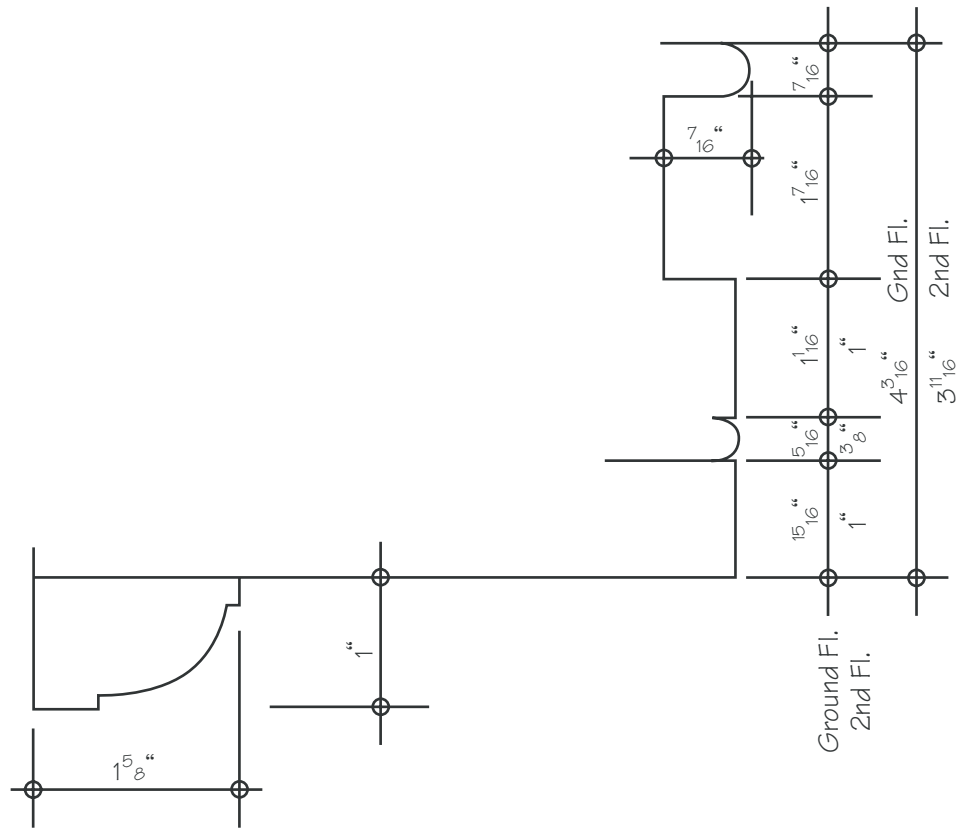
Jamb Profile-Ground Floor

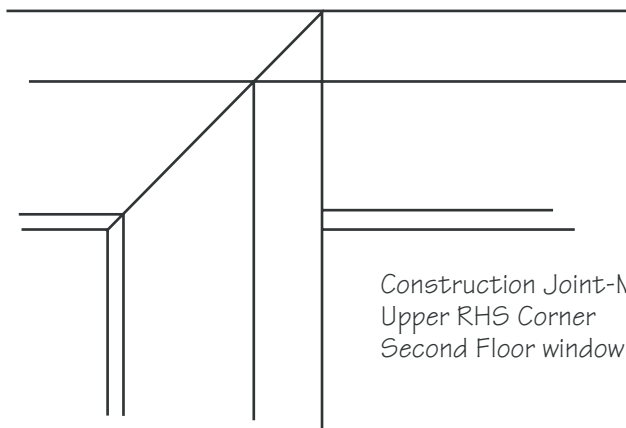
Construction Joint-Moulding
Upper RHS Corner
Second Floor window
